DEPARTMENT OF TRANSPORTATION**DIVISION OF ENGINEERING SERVICES**

Contract #: 04-0120F4Cty: SF/ALA Rte: 80 PM: 13.2/13.9File #: 99.28**WELDING INSPECTION REPORT****Resident Engineer:** Pursell, Gary**Address:** 333 Burma Road**City:** Oakland, CA 94607**Report No:** WIR-002797**Date Inspected:** 28-May-2008**Project Name:** SAS Superstructure**OSM Arrival Time:** 2230**Prime Contractor:** American Bridge/Fluor Enterprises, a JV**OSM Departure Time:** 830**Contractor:** Japan Steel Works, Ltd.**Location:** Muroran, Japan**CWI Name:** Makhmud Ashadi**CWI Present:** Yes No**Inspected CWI report:** Yes No N/A**Rod Oven in Use:** Yes No N/A**Electrode to specification:** Yes No N/A**Weld Procedures Followed:** Yes No N/A**Qualified Welders:** Yes No N/A**Verified Joint Fit-up:** Yes No N/A**Approved Drawings:** Yes No N/A**Approved WPS:** Yes No N/A**Delayed / Cancelled:** Yes No N/A**Bridge No:** 34-0006**Component:** Tower, Jacking and Deviation Saddles**Summary of Items Observed:**

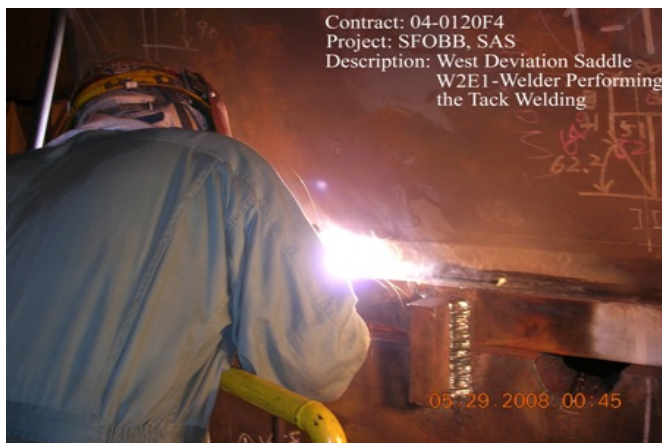
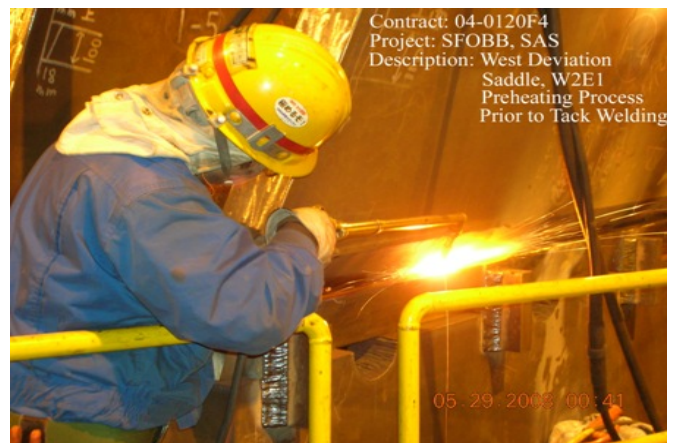
This QA inspector randomly observed the in process Shielded Metal Arc Welding (SMAW) for the tack welding of the structural Steel components for the West Deviation Saddles identified as W2E1. This QA inspector noted that it appeared the approved and latest revised WPS's were posted at the appropriate welding station and that each approved welder was entered in the latest revised Welding Personnel Log issued by Japan Steel Works, Ltd. The welding parameters, preheat and interpass temperatures were verified by this QA inspector utilizing a Fluke 337 clamp meter for the electrical welding parameters and Tempilstik temperature indicators for the preheat temperatures. The filler metal utilized by the JSW welding personnel was also verified. The QC inspector, Makhmud Ashadi appeared to perform the visual weld examinations, monitoring of the welding and the verification of the welding parameters as per the contract documents. The tack welding and inspection was not completed during this shift and appeared to be in general compliance with the contract documents.

The following digital photographs illustrate the observations of the activities performed on this date.
